Grasping the craft of cladding facades with wood: alder as a case study.

BRUN Géraldine¹, ALMEVIK Gunnar¹, JOHANSSON Karin¹, BJÖRLING Nils²

¹Department of Conservation, University of Gothenburg

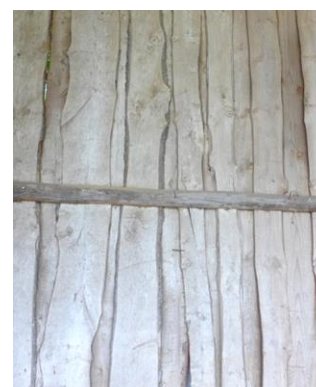
Fig. 4: inside of boards on boards on a barn, Västra Götaland. Photo by R. Carlsson.

In Swedish woodlands, alder and spruce are often found together (Hallander 1930, Herlitz 1932) and it seems like they have been perceived as equivalent for cladding the barn shown on

Fig. 4. Aspen is also found used together with spruce in Västra Götland (R. Carlsson, personal communication, April 2023). In Champagne, observed *tavillons* were made of alder, oak, or poplar. Alder deforms less than oak and poplar, possibly because it shrinks little (Gaudin et al 1999) and is the deciduous species with the straightest trunk (Grindhal 1941).
